1 Introduction

A customer asked us to solve a radiated noise issue of an ultrasonic parking radar device. The device failed CISPR 25, Class 4 narrow band radiated noise testing in the frequency range 530 kHz -2 MHz. The device consists of a controller with buzzer and two radar modules. Wiring consists of a supply cable to the controller and a communication/supply cable between controller and the two radar modules.

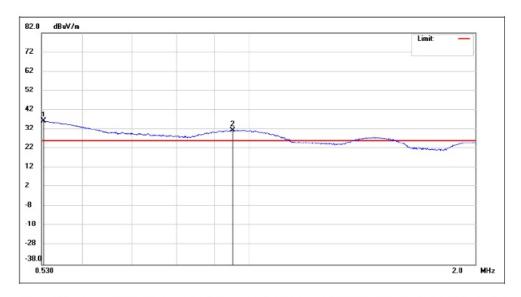
The customer supplied a screenshot of the failed test, measured in an anechoic chamber.

No.	Frequency	Reading	Factor	Result	Limit	Margin	Detector	P/F	Remark
	(MHz)	(dBuV)	(dB/m)	(dBuV/m)	(dBuV/m)	(dB)			
1	0.5335	35.91	0.30	36.21	26.00	10.21	peak	F	
2	0.9507	31.36	0.15	31.51	26.00	5.51	peak	F

The measured conducted emission spectrum exceeds the limit for CISPR 25 class 4 in the range 530 kHz to approximately 1.1 MHz. Furthermore the customer provided the information, that the test also failed with the module cable disconnected.

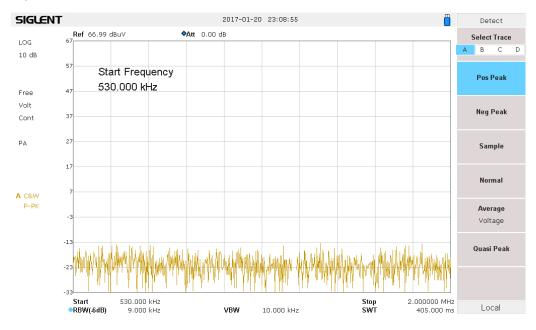
Span 530 kHz – 2 MHz; BW 9 kHz; Attenuator 0 dB; Preamplifier On; Average Voltage; Positive Peak Detector shows the spectrum below:

The displayed noise floor with this settings is approximately at $-20 dB\mu V$ which is impressive for a Spectrum Analyzer of this class. However it needs to be considered that the frequency range of interest is crowded with AM broadcast signals which are likely to be picked up.

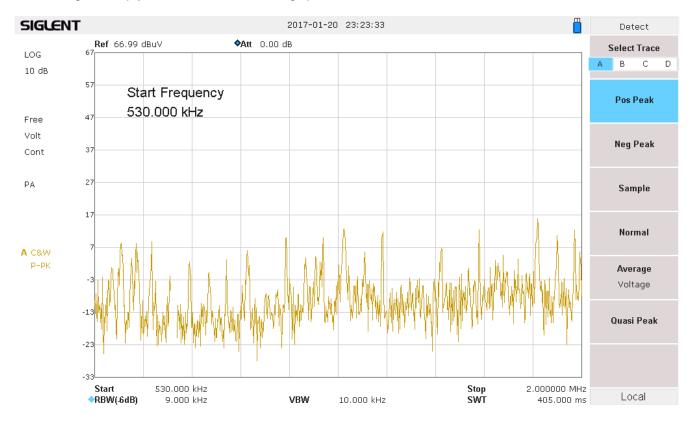
Connecting the empty TEM cell shows following spectrum:

As expected, the frequency range is crowded with broadcast signals. It next needs to be figured out, if the emissions of the DUT are above or in between with respect to amplitude.

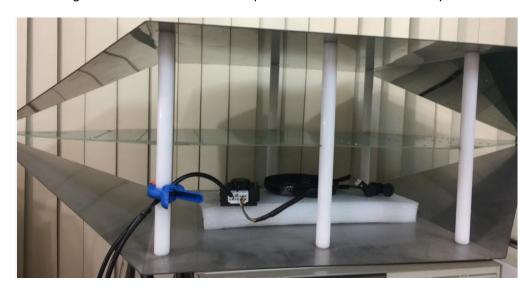
Next, the DUT including cables and radar modules is placed inside the TEM cell and powered ON:

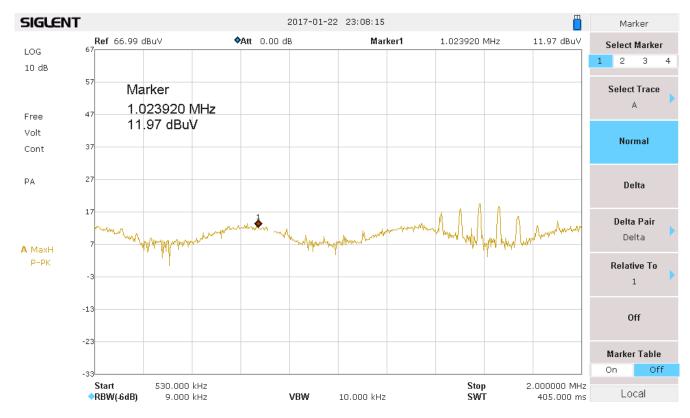
The Spectrum Analyzer trace is set to Max Hold:

The "hills" visible in the measured spectrum nicely correlate with the plot of the measurement in the anechoic chamber, despite the presence of some peaks from AM broadcast signals. The amplitude measured in the TEM cell is approximately 20 dBµV lower compared to the amplitude measured in the anechoic chamber.

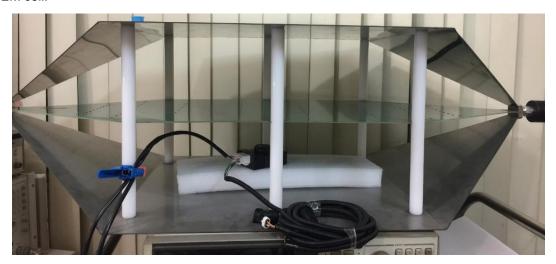
Next the cable is removed, as according to the customer, it also failed with the cable removed For simplicity sake, the cable remains physically connected, but is moved to the side with respect to the septum of the TEM cell.

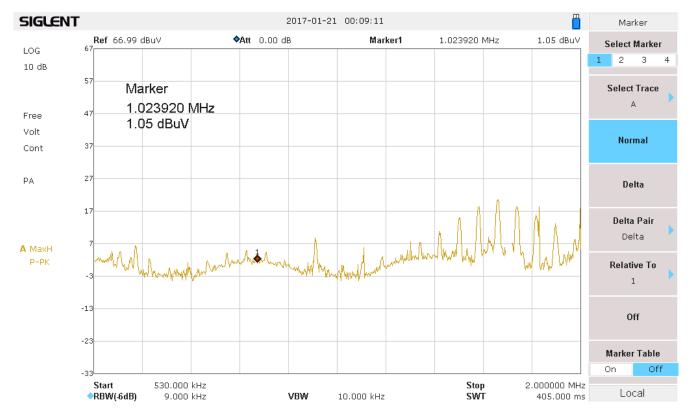
Surprisingly, shifting the cable significantly reduces the radiated noise of the DUT:

"Removing" the cable reduces the radiated noise at abpproximately 11 dBµV. Checking back with the customer turned out, that in fact not the cable was removed, but the two radar sensors were disconnected. This also explains why the relative amplitude of the spectrum "hills" are a bit different compared to the TEM cell measurement. The cable was set up straight in the anechoic chamber, whereas in the TEM cell it is coiled.

Removing the cable significantly reduced the radiated noise of the DUT. Though the customer removed the radar modules, he still failed the test. In fact, even in the absence of the modules, the controller continuously tries to communicate over the serial cable – without any timeout. Consequently it is highly probable, that the serial communication interface between the controller and radar modules is the culprit. In order to solve the issue it is necessary to apply some filtering to the interface.

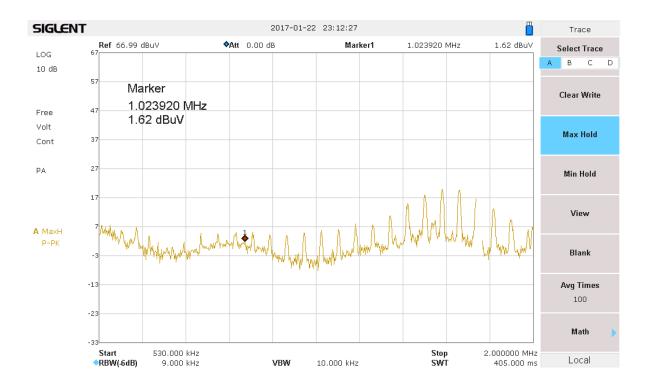
As ferrites are not very effective at low frequencies, it was decided to add resistors in series with the cable. This seemed to be an especially practical approach, as there were already 0 Ohm series resistors assembled on the PCB. Replacing the 0 Ohm series resistors with 1K reduced the radiated noise level at approximately 12 dBµV. However it turned out that the serial interface did not reliably operate over the specified supply voltage range any more. Finally it was also necessary to adjust a few other resistors in the transistorized serial interface circuit in order to solve the radiated issue and keep the performance of the serial interface within specs. A few modifications and measurements later, the result looks as below:

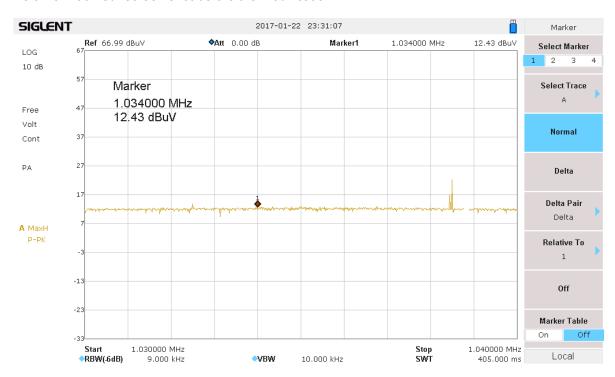
In order to get a clearer picture, the span of the Spectrum Analyzer was reduced and set in between two adjacent broadcast channels.

Below a "zoomed" screen shot before the modification:

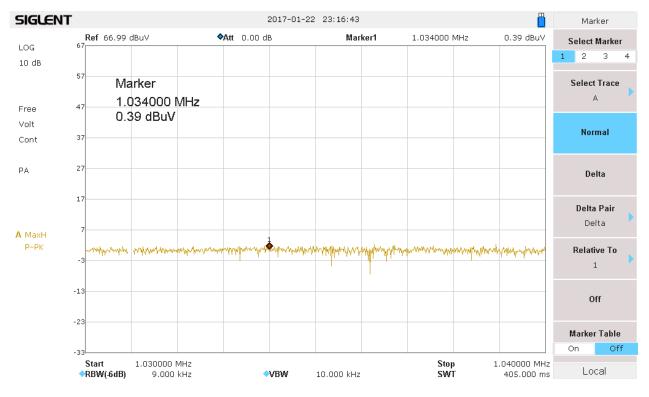
Next a zoomed screenshot after the modification:

The modification gave a 12 dBµV reduction of the radiated emissions level at the investigated frequency.

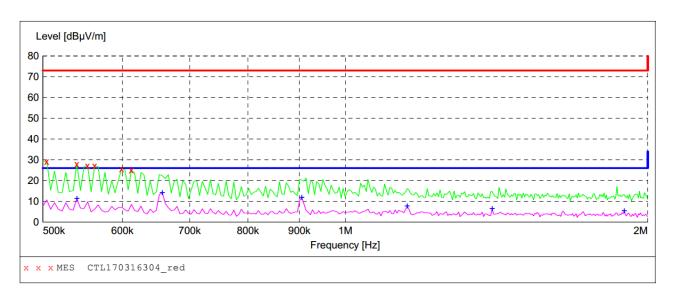
Below the final measurement plot from the test house, after modification:

The device passed the radiated noise test in the range 500kHz to 2MHz and furthermore the remaining frequency range up to 2GHz.
